York Region Home Inspections

Inspection 1446

October 5, 2018

Inspection Address: 672 Savolune Blvd, Milton, ON

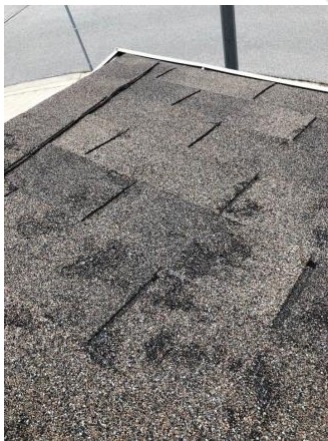
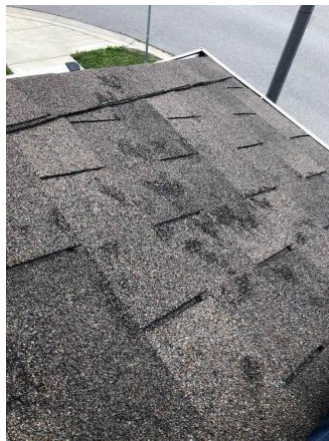
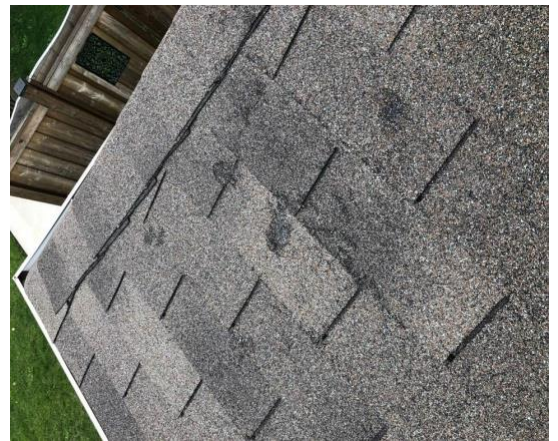
### 3.0

- Recommend RR of shingles located on east face of home.
- Shingles are deteriorated and no longer doing its intended job. Potential for water penetration and ice buildup recommend repairs to be done immediately before winter arrives.
- Approximately 20 shingles need to be repaired or replaced.

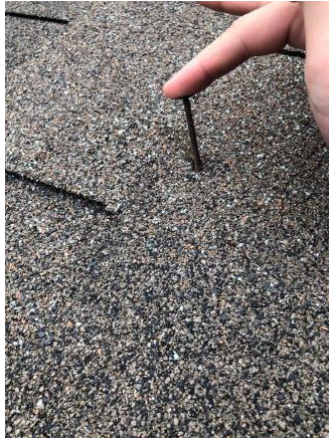
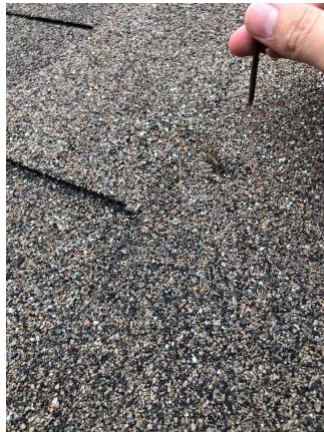
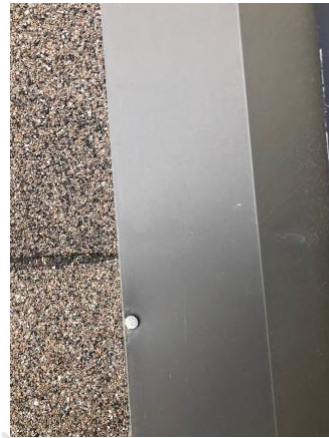
3.2

-Missing roofing sealant on roofing nailing's. Sealant needs to be used to plug nailing's to prevent water penetration on to underlayment & wooden rafters.

-Step flashing nailing's need to be filled with sealant as well.

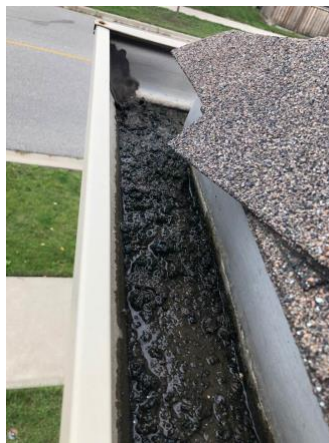
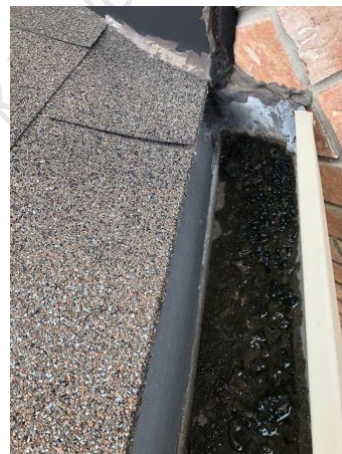
3.3

-Recommend cleaning gutter system found on eastern section of roof. Currently clogged and not allowing drainage.

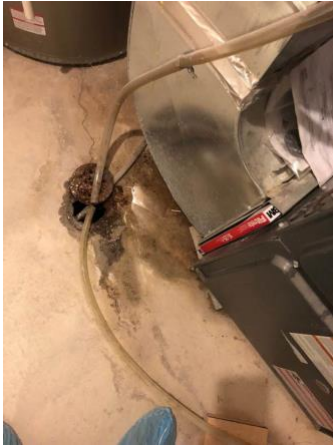
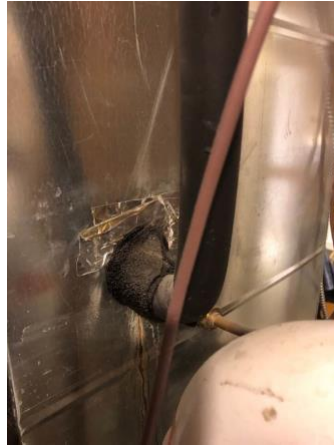
5.3

-Recommend fastening condensation lines for forced air heating system. Currently discharging onto foundation slab.

-Recommend servicing forced air heating system.
